DONALD MCGOWAN

LODGE FARM  
WOODSIDE GREEN  
BISHOP'S STORTFORD  
ESSEX

## **Ecological Assessment**

January 2017  
7124.EcoAs.dv4

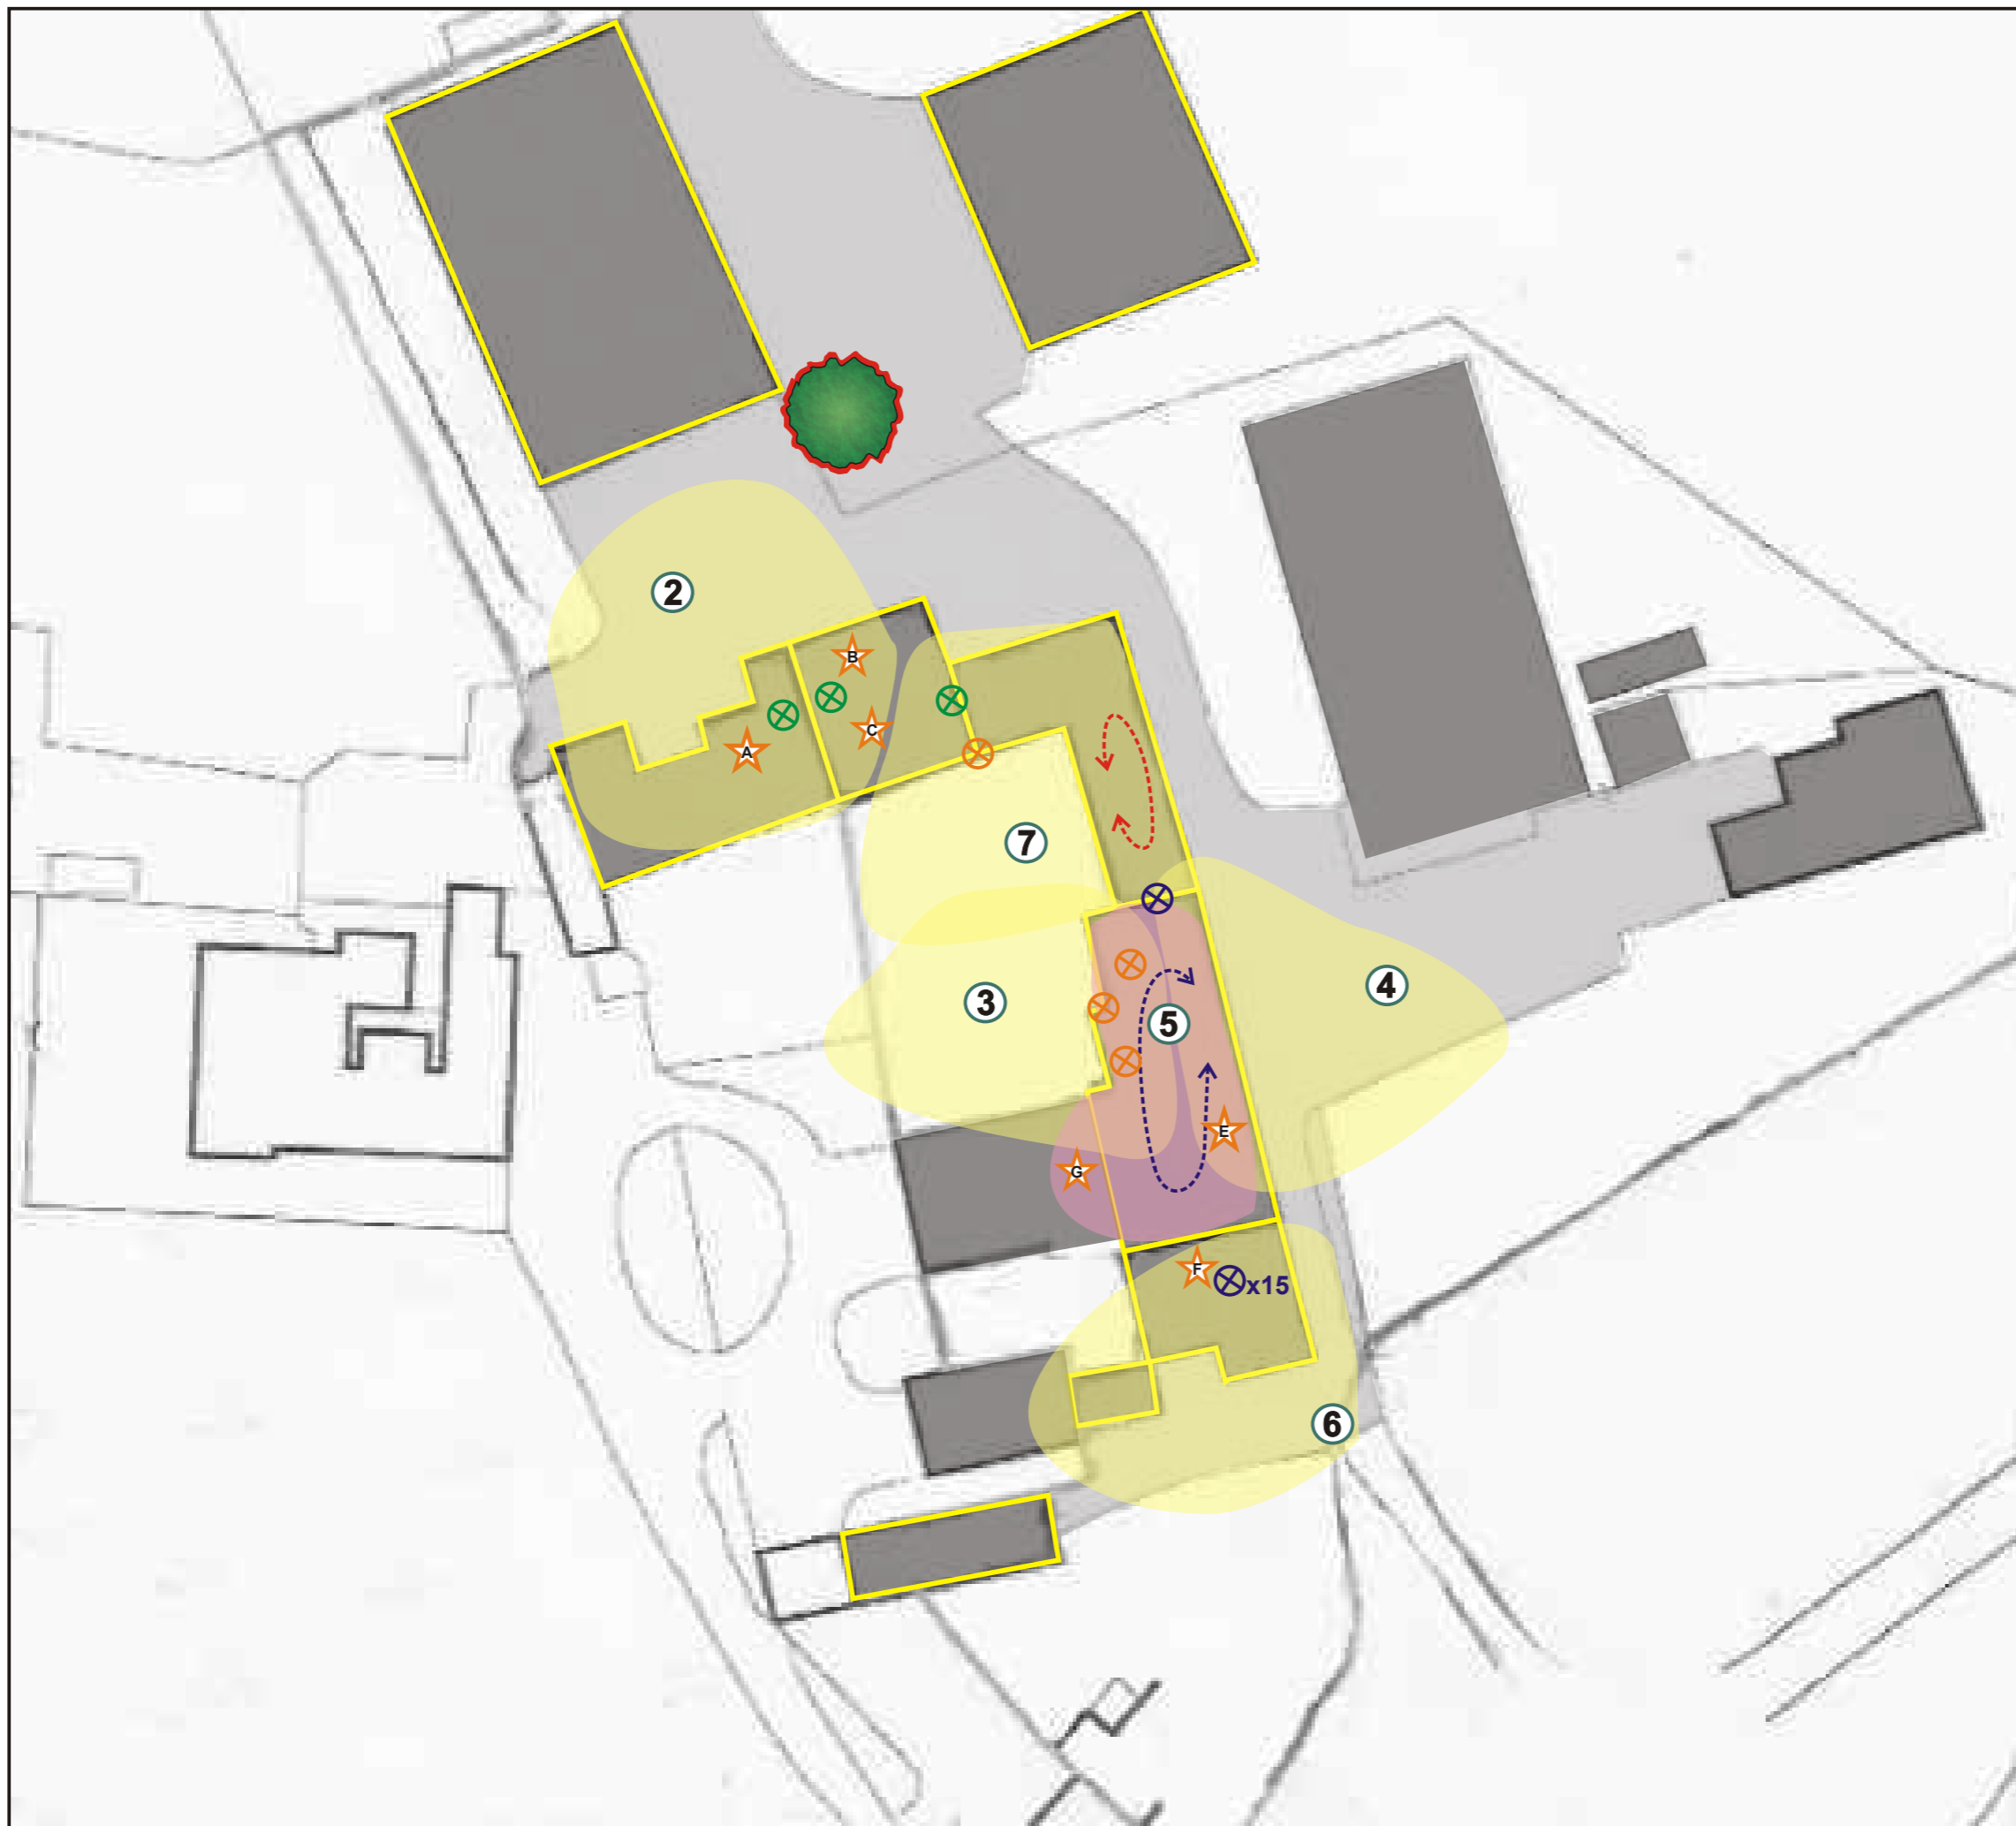
**PLAN ECO4a**

- 4.3.15. The results of the dawn re-entry survey completed on the morning of 23 June are summarised below and illustrated on Plan ECO4a. For reasons of clarity, owing to the high level of activity, only the re-entry points and flight paths of bats inside buildings are detailed.
- 4.3.16. It should be noted that there was a thunderstorm at the beginning of this survey however, there were breaks in the rain which provided a valuable insight into the bat activity as bats were observed emerging and re-entering in these breaks.
- 4.3.17. The re-entry survey recorded three bats re-entering building B4: one Soprano Pipistrelle and two unidentified bats. The two unidentified bats were observed going underneath tiles but were not detected by the EM3+ detector.
- 4.3.18. A single bat, again not detected by the EM3+ detector, was observed going underneath a tile on building B3.

Bat Re-entry Survey June 2016

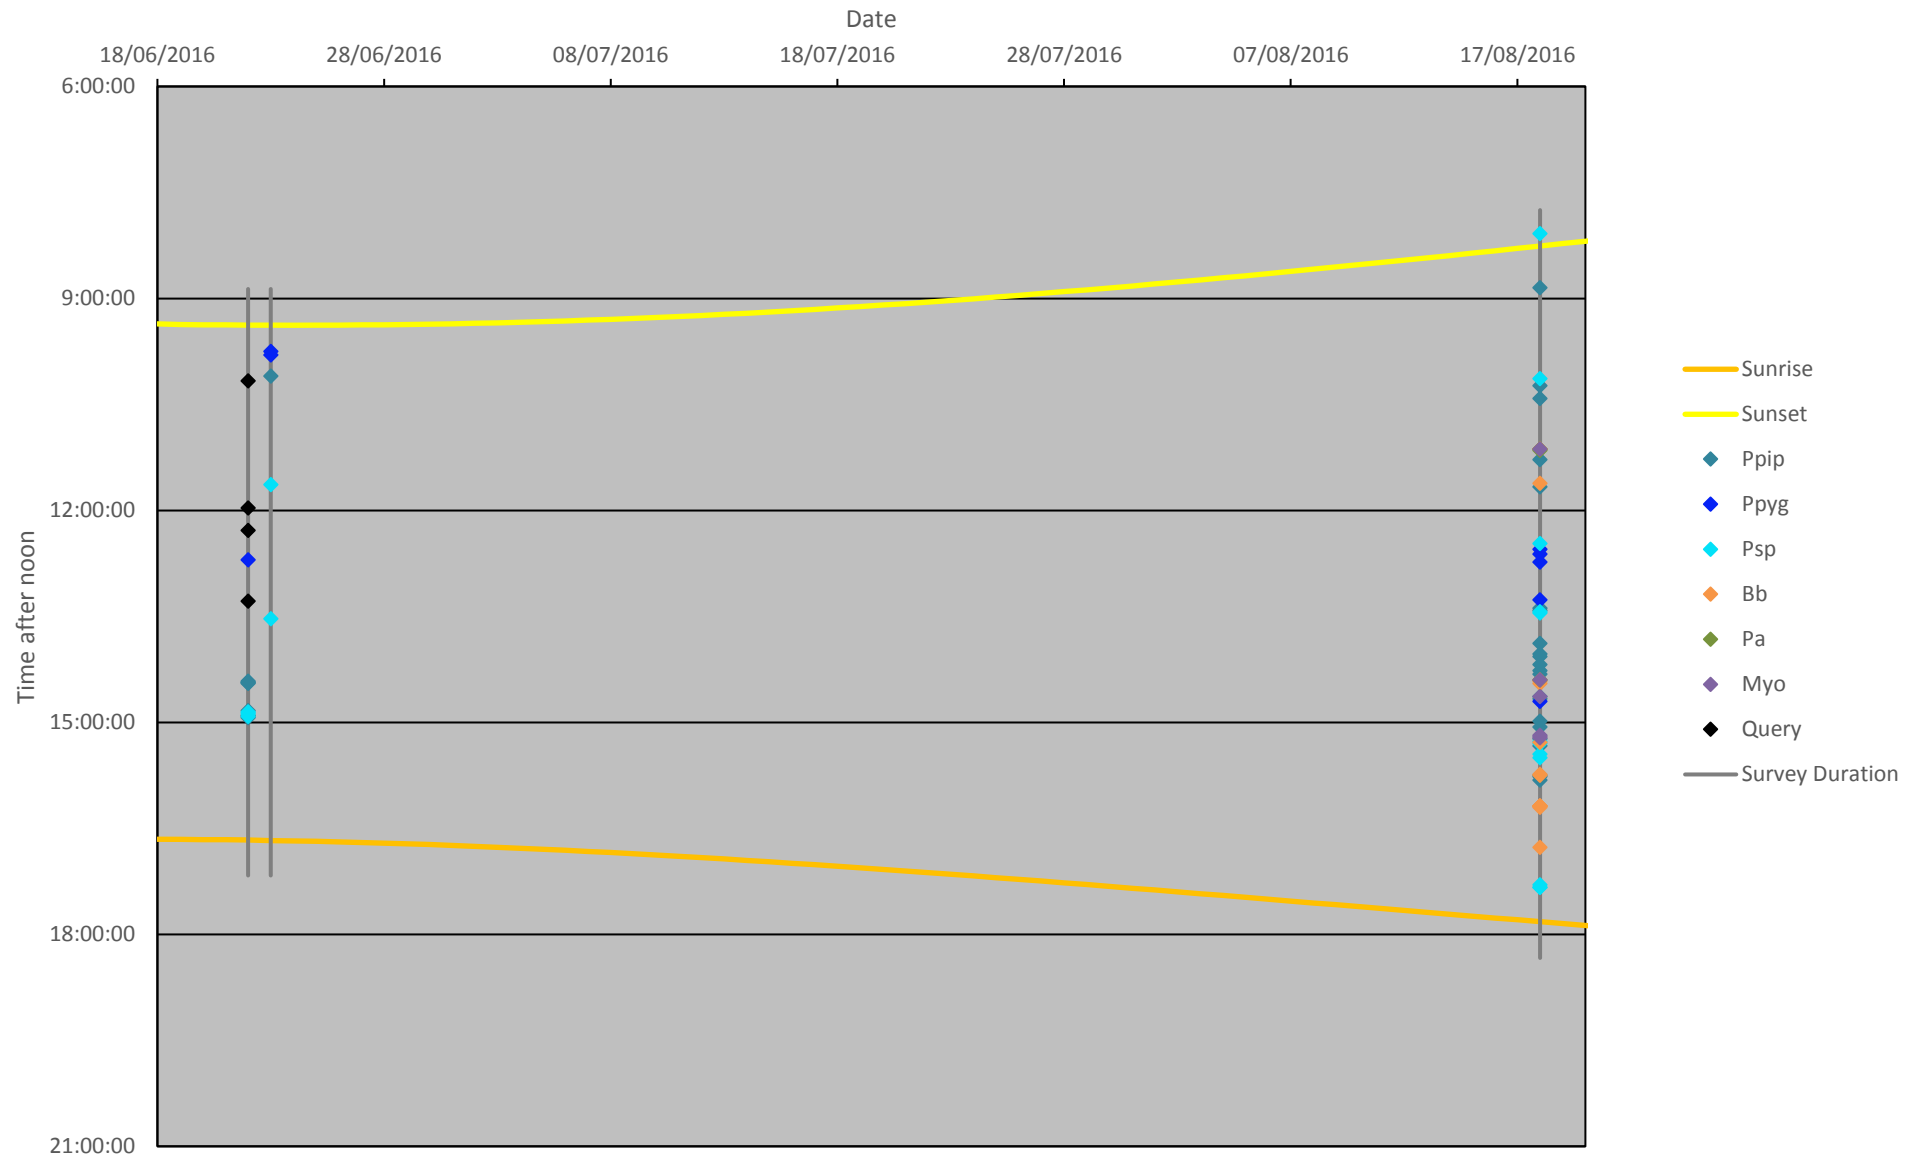
Figure 1a: Position A

- 4.3.46. **Position A.** At position A, inside building B3, there were 20 registrations on the first night attributed to Common Pipistrelle (11 registrations), Soprano Pipistrelle (one registration) and Pipistrelle sp. (four registrations). Four query calls were noted which were not identifiable to species level owing to the length and clarity of the calls. The earliest registration was a query recorded 48 minutes after sunset and the last registration was a Common Pipistrelle 1 hour 44 minutes before sunrise. On the second night there were only five registrations throughout the night attributed again to Common Pipistrelle (one registration), Soprano Pipistrelle (two registrations) and Pipistrelle sp. (two registrations). The first was a Soprano Pipistrelle recorded at 23 minutes after sunset and the last registration was an unidentified Pipistrelle sp.. See Figure 1a for a graphical representation of this data.

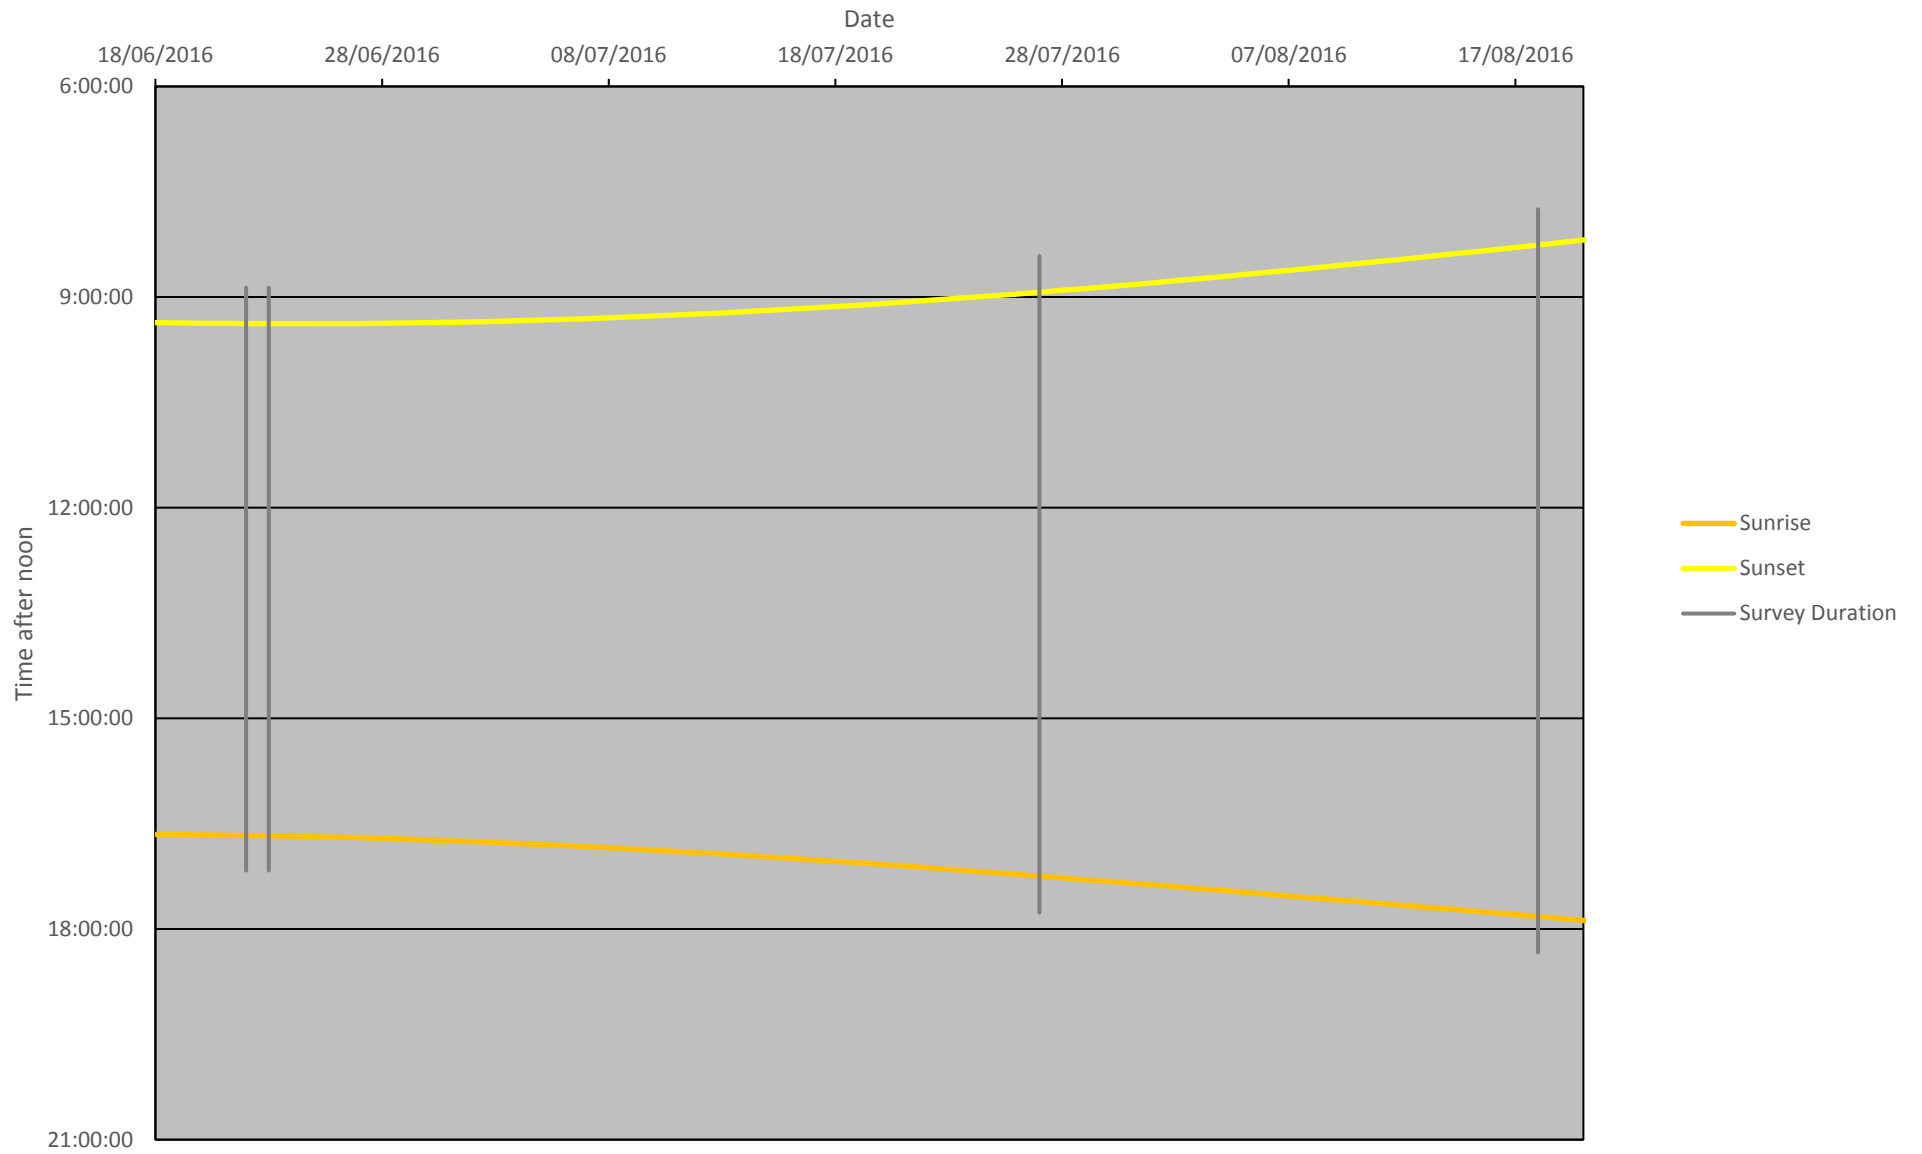
Figure 1f: Position F

- 4.3.52. **Position F.** Nothing was recorded on the bat detector at position F inside loft 2 of building B7 and it is unclear whether this was due to software malfunction or no bats were present. No evidence of bats was recorded within the loft when the detector was being deployed and collected and there was no reason to suspect a failure save for no data being recorded.

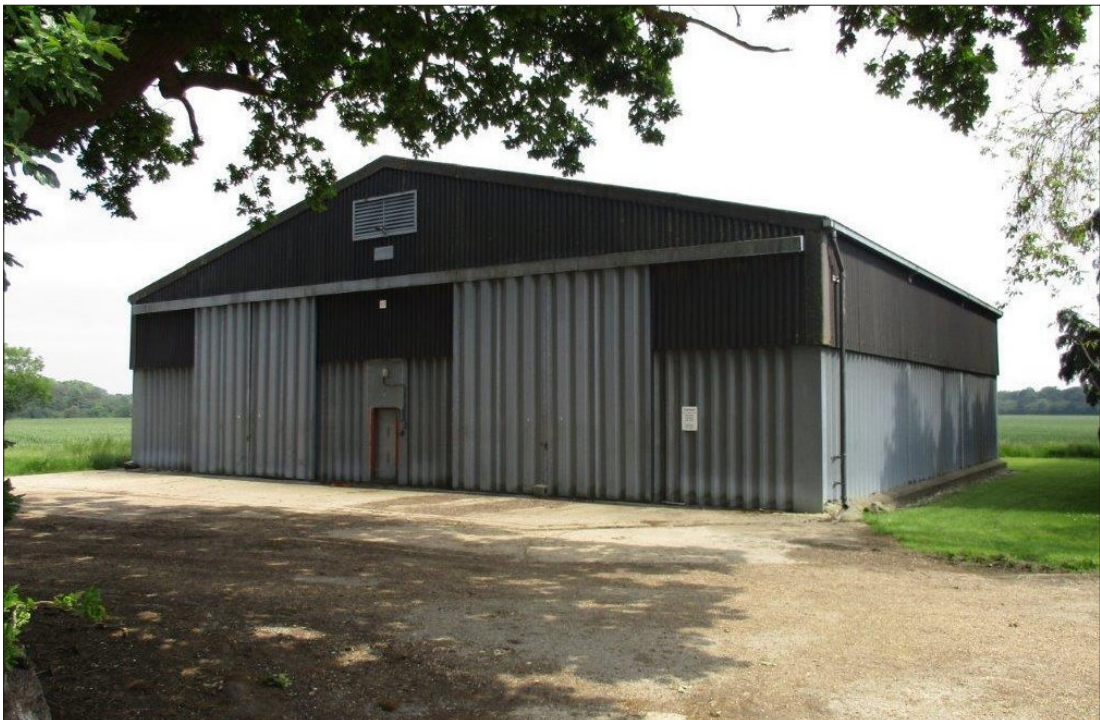
PHOTOGRAPH 2: Building B2

3.4.3. Building B2 is a large agricultural building used as a grain store (see Photograph 2). It is similar to building B1 in that it is a single storey building with corrugated metal cladding on the walls and roof.

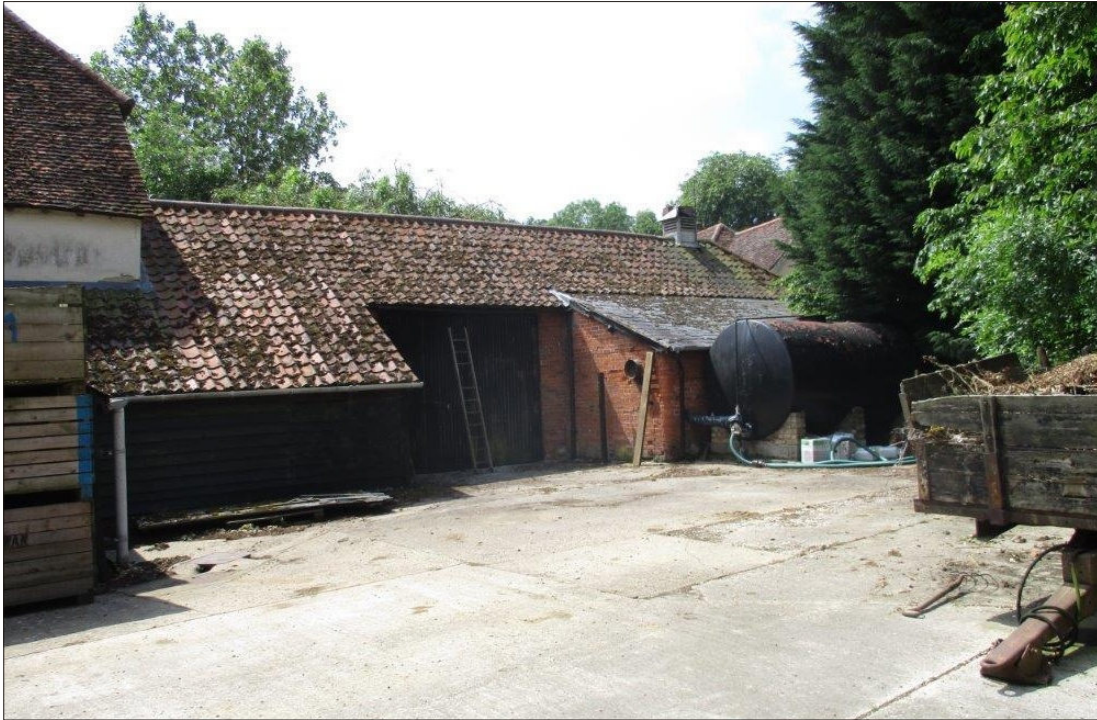
PHOTOGRAPH 3: Building B3

3.4.4. This building is attached to building B4. It is a single storey building tiled with a combination of ceramic tiles and slate tiles. It has breeze block and brick walls and painted wooden beams. Part of the exterior is covered in wooden cladding (see Photograph 3). There are multiple access points and the large barn doors were open at the time of survey.

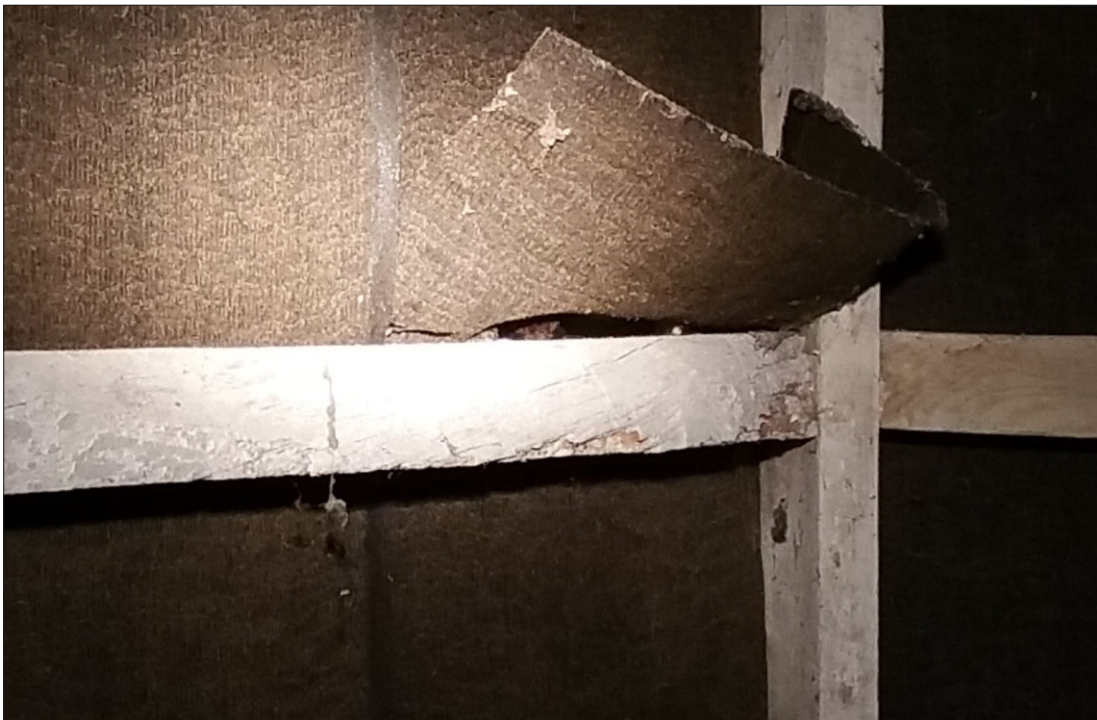
PHOTOGRAPH 4: Bat Roosting in Building B3 in August 2016

4.3.2. **Building B3.** Bat droppings were found on the floor in June and identified as *Barbastelle Barbastella barbastellus* droppings. During a search of the building in August a single bat was found roosting between the wooden rafters and roofing felt (see Photograph 4). The data recorded by the static bat detector, positioned close to the roosting bat the night before the bat was found, has proved inconclusive in determining the species owing to multiple species being recorded throughout the night.

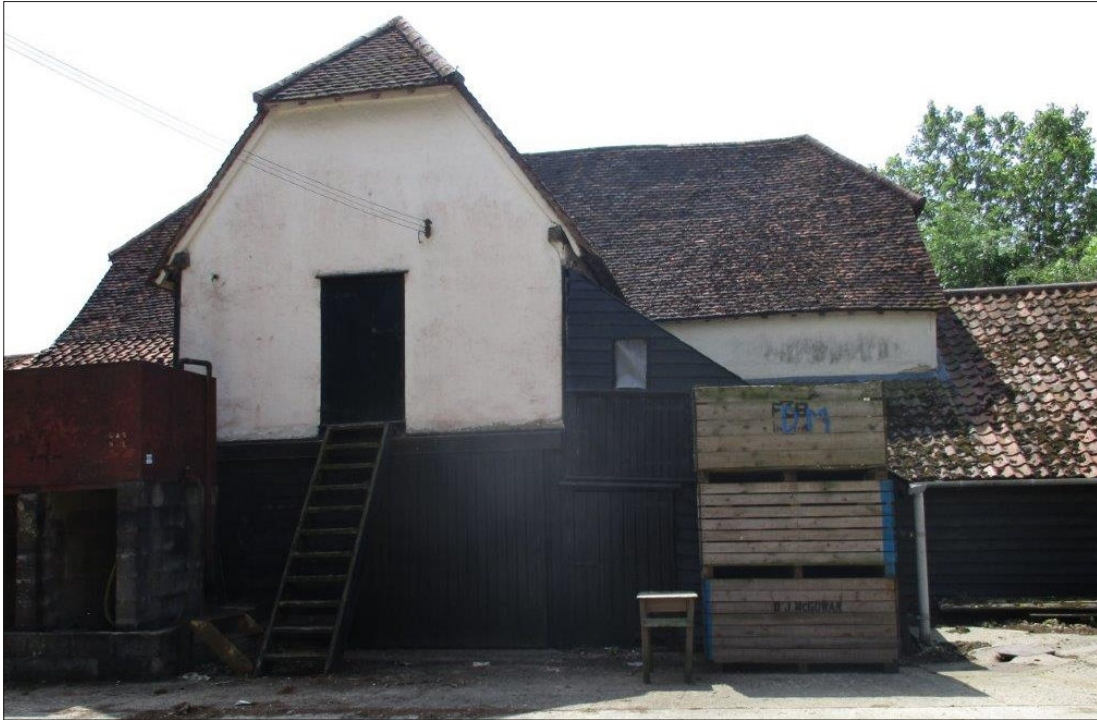
PHOTOGRAPH 5: Building B4

3.4.5. This is the former granary situated between buildings B3 and B5. It is a two storey structure with a tiled pitched roof (see Photograph 5).

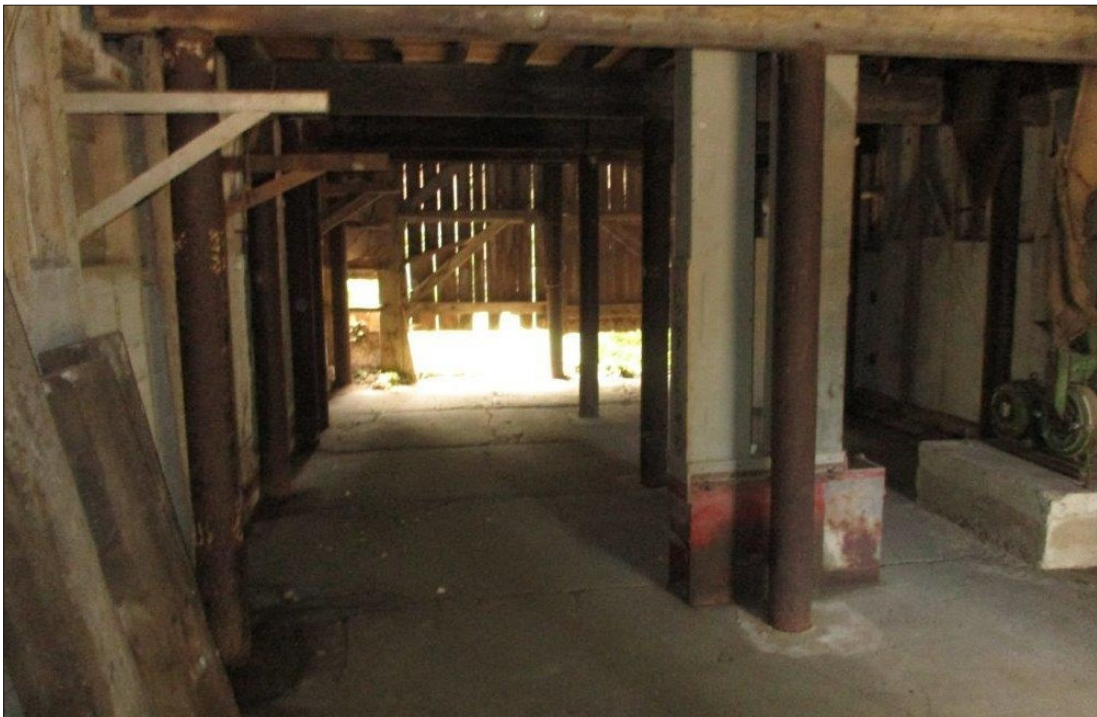
PHOTOGRAPH 6: Ground Floor Room of Building B4

the southern entrance significantly damaged at the base creating a large gap (see Photograph 6) combined with a number of holes in the walls.

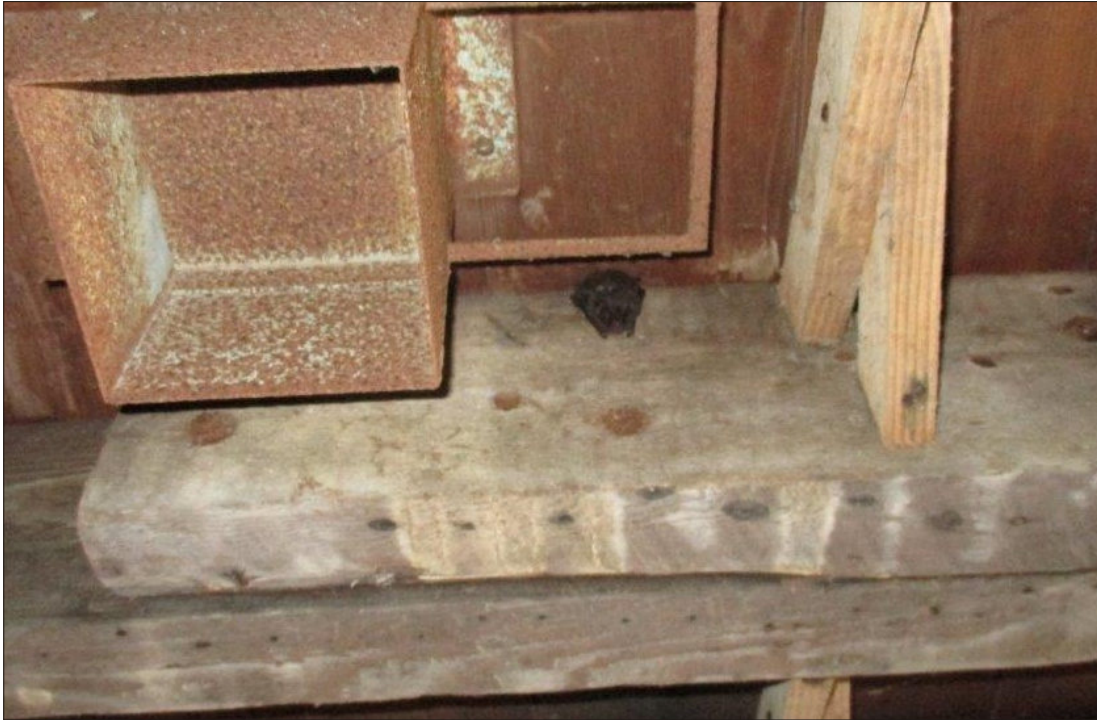
PHOTOGRAPH 7: Bat Roosting in Ground Floor Room of Building B4 in June 2016

4.3.3. **Building B4.** A single Pipistrelle *Pipistrellus* sp. bat was recorded roosting on a wooden beam in the ground floor room during the initial survey on 9 June 2016 (see Photograph 7). This room had been recently cleaned and no bat droppings were found in this area.

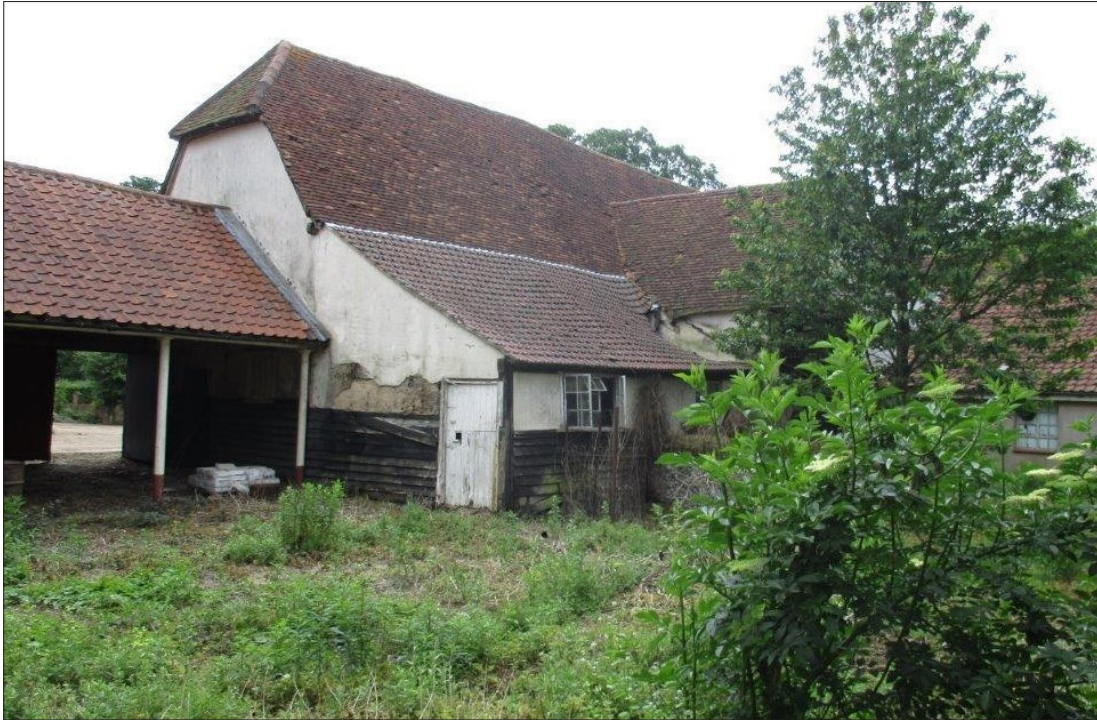
PHOTOGRAPH 9: Buildings B5 and B6

- 3.4.9. This is a Grade II listed barn. It is a large wooden structure with exposed rough wooden beams and a pitched tiled roof lined on the inside with roofing felt (see Photographs 9, 10 and 11). There are significant gaps between the tiles and the roofing felt and the felt is damaged in places. It has large metal gates / barn doors which were open at the time of survey. There is also a door where a second storey would once have been. There are significant gaps around all of the doors. The floor of the barn is concrete. The barn is currently being used for storing miscellaneous items as well as vehicles and two silos.

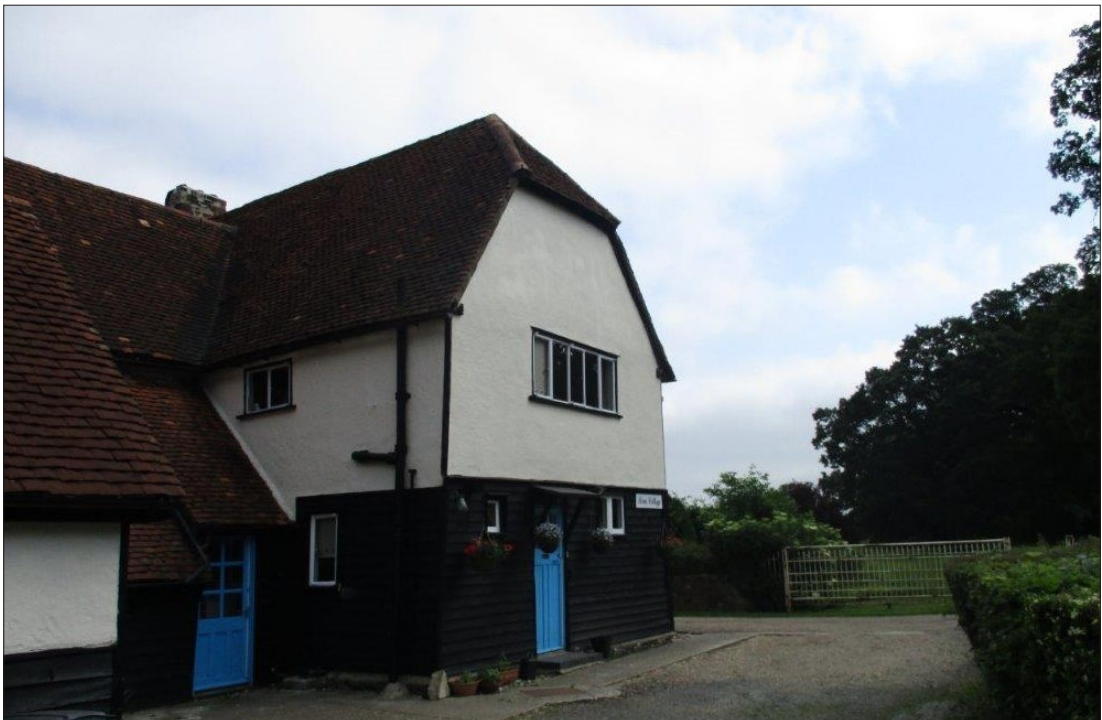
PHOTOGRAPH 12: Building B7

- 3.4.10. Building B7 is the occupied barn cottage attached to the main barn. It is a two storey Grade II listed building with a pitched tiled roof, similar to B6 (see Photograph 12). The interior is in good condition and is in frequent use.

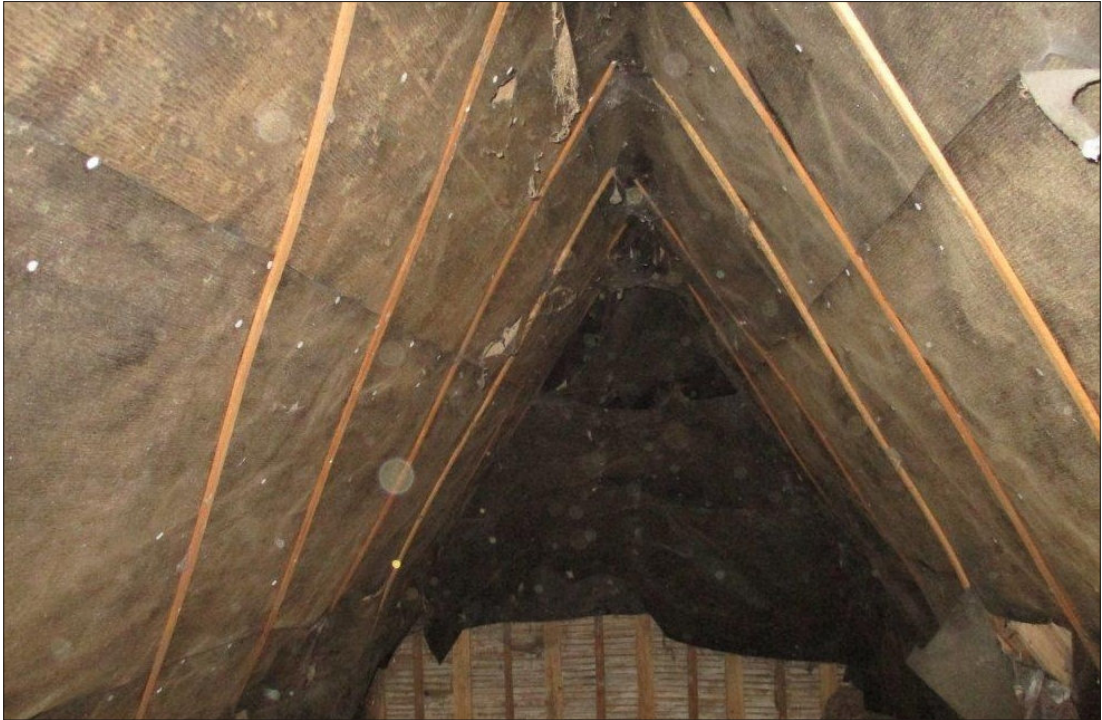
PHOTOGRAPH 13: Loft 2 of Building B7

- 3.4.13. The second loft space is accessed through the office room (see Photograph 13). It is slightly larger than the first loft at approximately 2.5m in height, 4-5m in width and 20m in length and there is a brick chimney breast. There are fewer items stored within this space. It was again noted that the apex was covered in cobwebs and rat droppings were recorded. An empty wasp nest was also present. No obvious access points were noted.

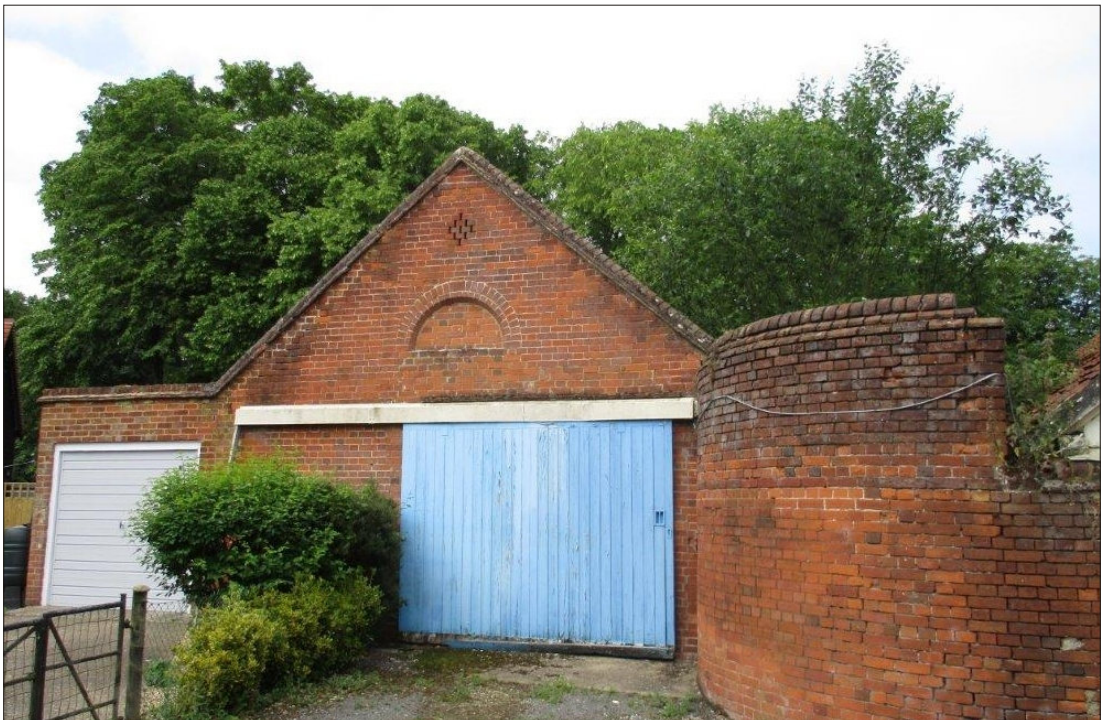
PHOTOGRAPH 14: Building B9

- 3.4.15. Building B9 is a larger garage than B8 (see Photograph 14) used for storage. It has a pitched roof with roofing felt liner with edges of corrugated asbestos sheets, brick walls and wooden rafters. There are a number of skylights making it quite light inside. The interior is dusty and has significant cobwebbing. It was noted that there were some plants coming through holes in the roof. Mice droppings were recorded.

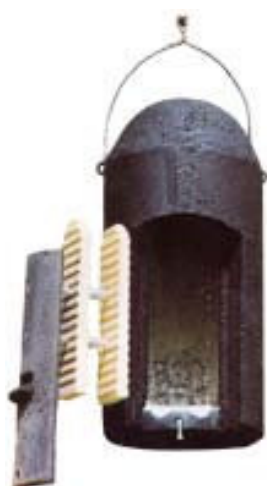
The 75% wood sawdust, clay and concrete mixture is ideal, being durable whilst allowing natural respiration and temperature stability. These boxes are rot and predator proof and extremely long lasting.

Boxes can be hung from a branch near the tree trunk or fixed using 'tree-friendly' aluminum nails.

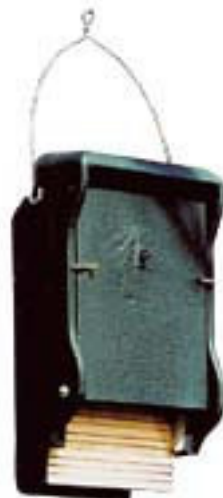
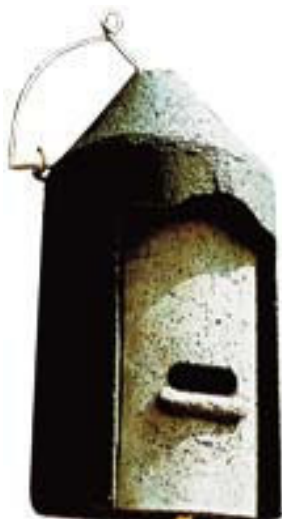
## 1FD Bat Box

A larger than standard bat box, with two additional roughened wooden panels inside to be used by the bats as perches.

*Height: 43cm*

*Weight: 8.3kg*

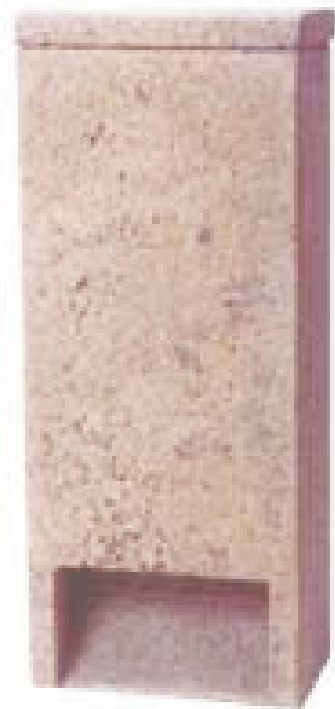
## 2F Bat Box

A standard bat box, attractive to the smaller British bat species. Simple design with a narrow entrance slit on the front.

**Entrance Depth:** 2cm

**Weight:** 13kg

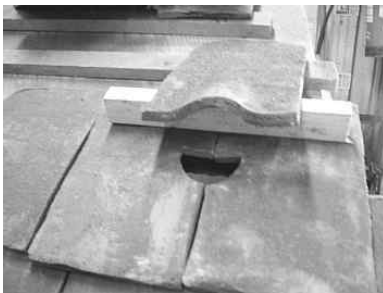
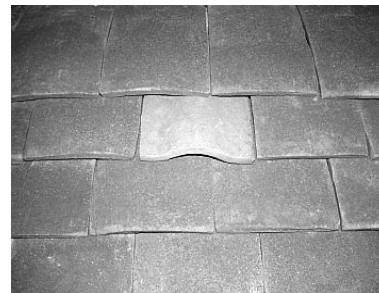
Tudor Roof Tiles Co. Limited can provide purpose made access points within your roof tiles or ridge tiles. The Bat Access Set can form part of a mitigation package required by law for existing roosts or as potential access where a roost had not previously been present.

Available in all 5 Tudor colours, or in Natural Clay (without sand face), the Bat Access Set presents a bat optimised entrance to the under-felt, or to the loft when the under-felt is opened.

For use within the roof tiles, the top 'tunnel' tile offers the bat an 18mm high x 165mm long (approx.) tunnel to an entrance hole in the undertiles. This allows the bat to crawl into the roost area.

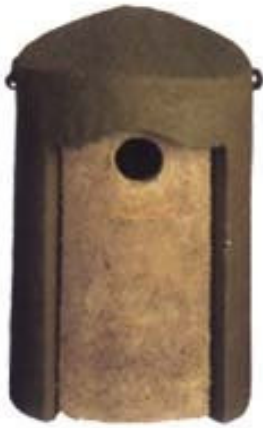
## 1B Bird Box

This is the most popular box for garden birds and appeals to a wide range of species. The box can be hung from a branch or nailed to the trunk of a tree with a 'tree-friendly' aluminium nail.

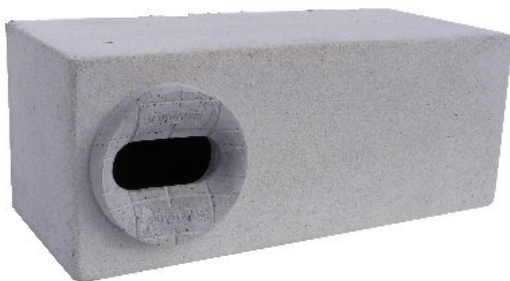
Developed in association with the German Environmental and Nature Conservation Organisation BUND, this box is ideal for inclusion in heat insulation systems on external walls. The ring-shaped entrance enables the box to be installed flush with the wall surface and is designed to make approach to the box much easier for Swifts.

*Dimensions: 135mm high x 340mm wide x 150mm deep  
(plus 17mm entrance ring)  
Weight: approximately 2.7kg*

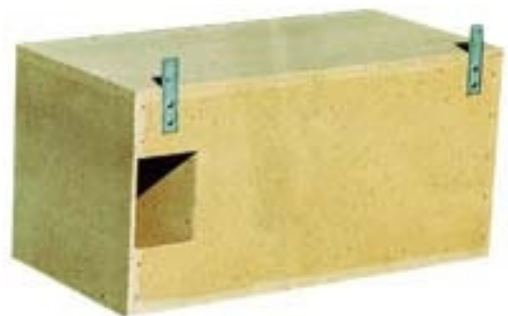
## No 23 Barn Owl Box

This box is best sited on the interior wall of barns or church towers. Only a small opening is needed on the outside of the building to serve as an entrance. There is an inspection panel at the back of the box.

*Made of waterproof wooden boarding  
Dimensions 100cm x 50cm x 50cm  
Entrance hole 14cm x 19cm*

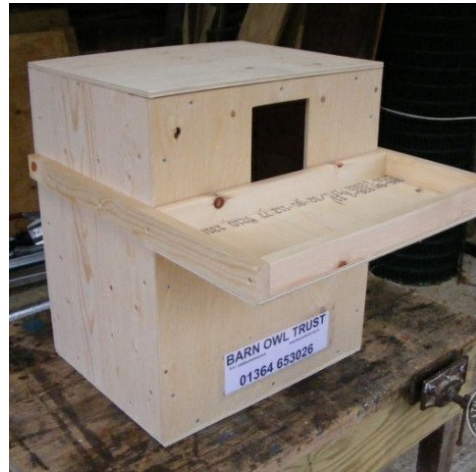
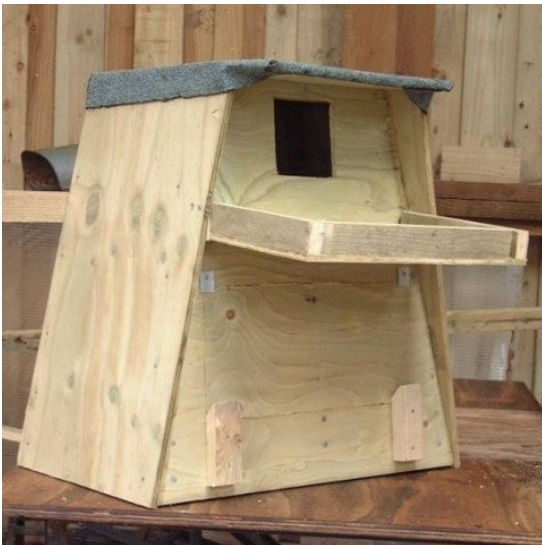
Handmade at the Barn Owl Trust for indoor use. This box is designed to be safer for owlets.

*FSC-approved 9mm Plywood,  
Dimensions 510mm wide x 410mm deep x 610mm high  
Weight 14kg*

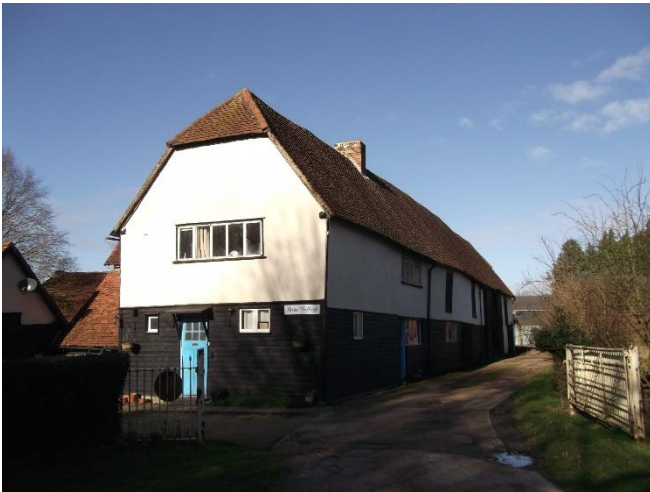
The main barn is a two storey timber framed six bay building with partly plastered and partly weatherboarded walls. The roof is steeply pitched with plain clay tiles, with cropped hips.

The section to the southern end (being the closest part in the image left) was converted into a dwelling in the mid C20<sup>th</sup>.

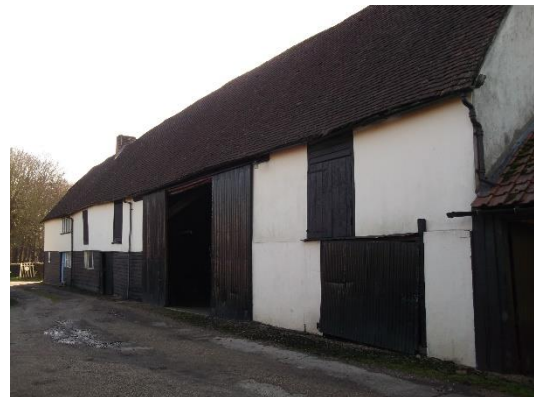
The image right shows the east elevation of the barn.

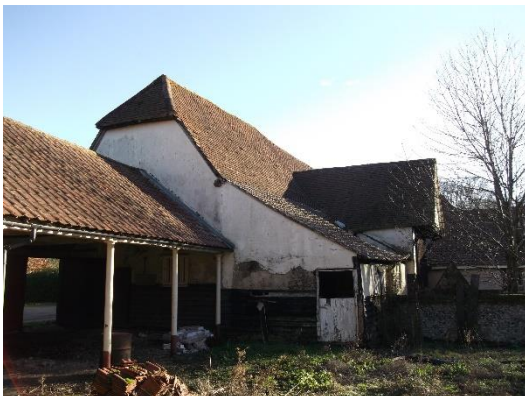
The image left shows the northern end of the barn, where it adjoins the open fronted cattle shelter.

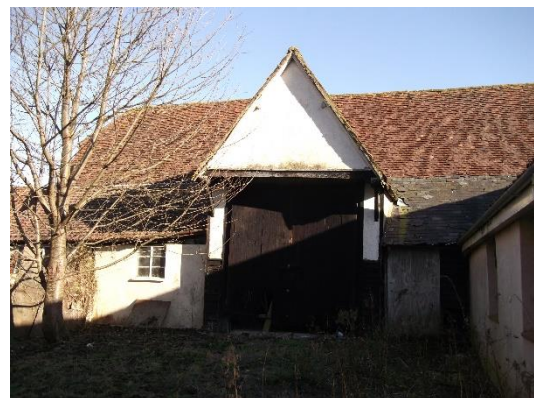
The image right shows the west elevation, to the cattle yards. The midstreys has a jettied gable.

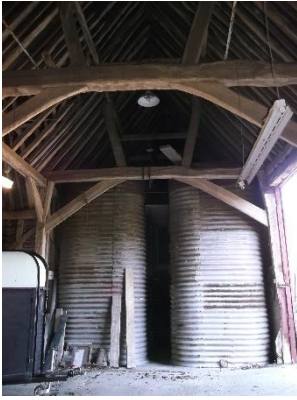
Internally the frame is exposed showing the clasped purlin roof with close studding walls and a low brick plinth. At the northern end, beyond the midstrey (image left) are two bays, filled with grain bins and dressing equipment on a first floor level. There is also a grain handling pit to the north east corner.

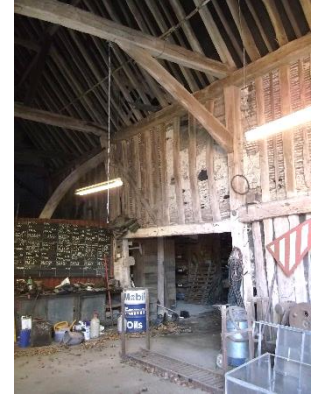
The frame posts are jowled and the roof ties have both straight and arched braces in various locations. In the second bay from the south, the braces are inverted to form a grain wall. Some of the ties have queen struts.

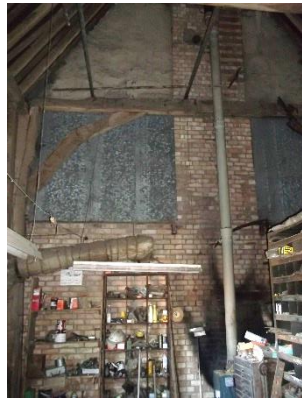
The division between the dwelling and the barn at the southern end is infilled with masonry. There is a central chimney.

The lower parts of the walls are generally clad with weatherboard and the upper (and internal partition) walls are lath and plaster.

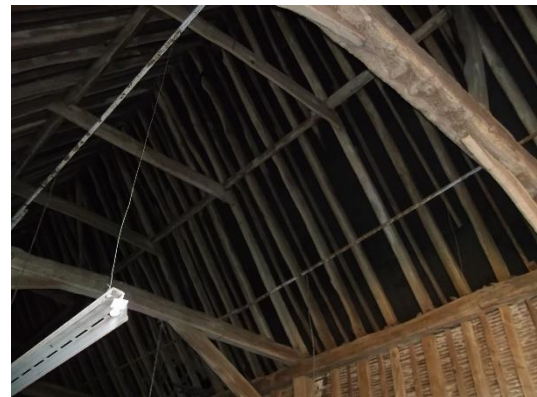
The roof has a mixture of earlier rafters and many infill pieces, scantlings and formally cut rafters. There are principal ties at each frame bay. It has underfelt.

Generally the barn and the frame are in good order, with some areas requiring repair to the south wall of the midstrey and to the roof structure of the lean-to either side of the midstrey.

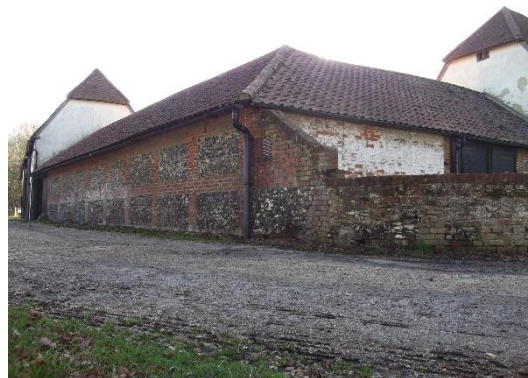
The outer walls of this part are flint panels with brick dressings (image right) to the east elevation and the curved return wing wall. The north wall is mostly brick with two smaller flint panels.

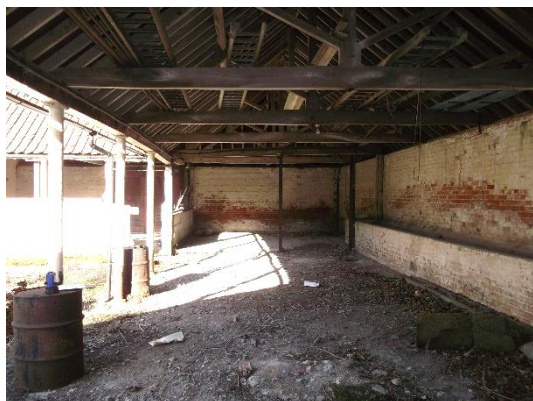
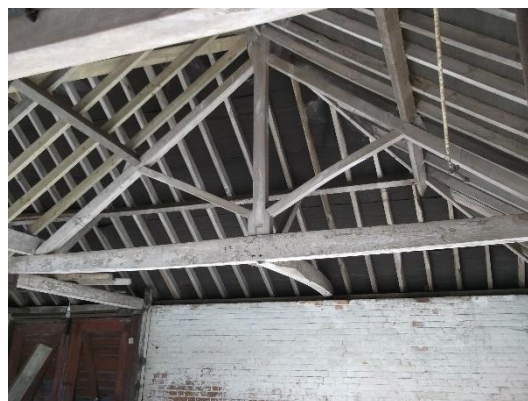
The open roof structure indicates that this part of the building is considerably later than the main barn (images left and below) but is of a particularly good quality. The valley section of the roof has been very recently repaired. The roof has underfelt.

The floor is bare earth over much of the plan.
