DONALD MCGOWAN

LODGE FARM  
WOODSIDE GREEN  
BISHOP'S STORTFORD  
ESSEX

## **Ecological Assessment**

January 2017  
7124.EcoAs.dv4

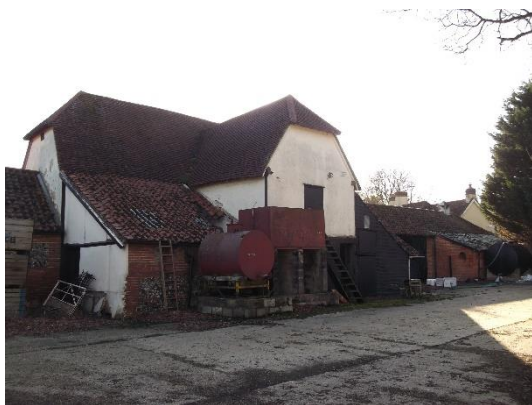
## The east/west range

This part of the barn complex is a two storey main section with a single storey wing to the west. It has a plain tiled cropped hip roof to the main range and pantiles or slates to the outshots and wing. There is a two storey waggon porch to the north with lean-to outshots flanking it.

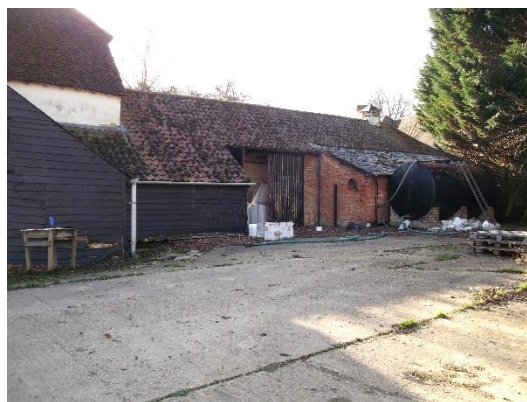
The western wing (image right) is single storey with outshots.

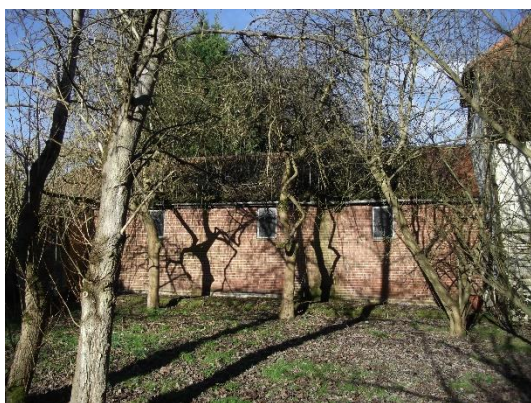
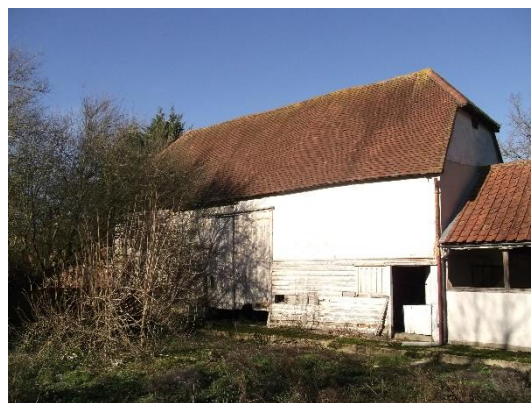
The images above show the south (cattle yard) elevations to the barns. The wall to the wing is a modern brick/block cavity wall and the main barn is timber framed with plastered walls over weatherboard.

The frames have been much altered and repaired with the loss of the south wall of the western range, it being replaced with a modern cavity masonry wall, albeit with some earlier timber posts within the inner leaf. Much of the earlier lath and plaster to the inner walls is lost, giving way to brick and blockwork noggin.

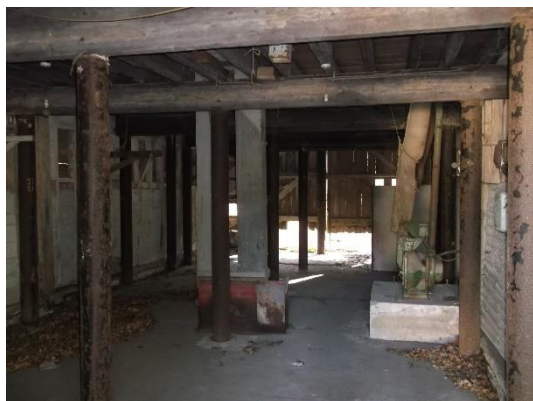
The timber frame and roof are generally unremarkable, with a clasped purlin configuration, in oak. Many of the internal walls and parts of the external walls have been infilled with concrete or masonry noggin (with blockwork) and much of the first floor sections are propped with steel or timber props (image left). There are grooves for winnowing boards on the south door.

Generally it is in reasonable condition, with a considerable proportion of the original frame in place. Parts of the lean-to roof to the east of the porch require reinstatement and repair as do parts of the external wall thereto.

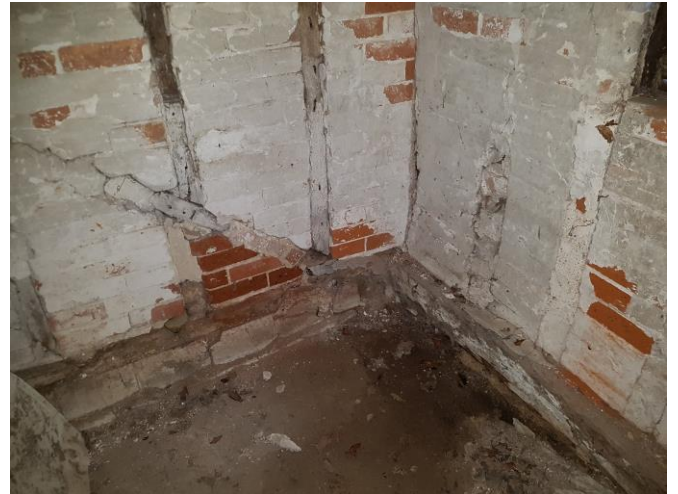
Unit 1 – Sole Plate

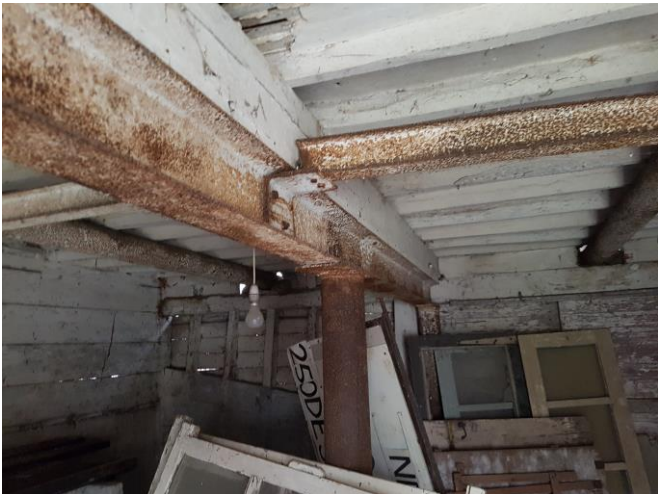
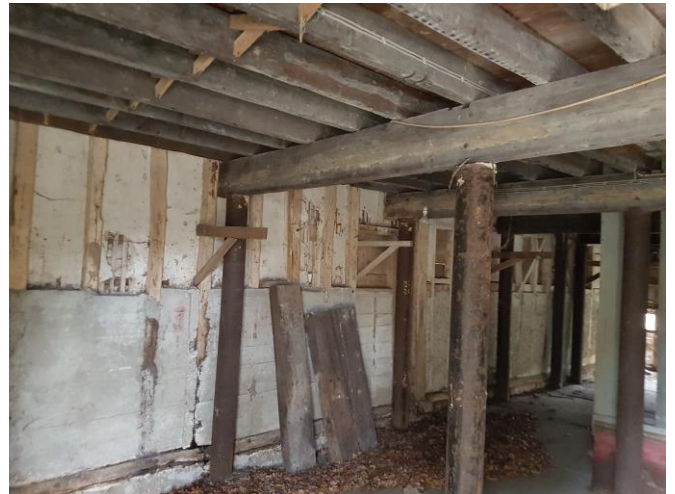
Unit 2 – Floor Strengthening

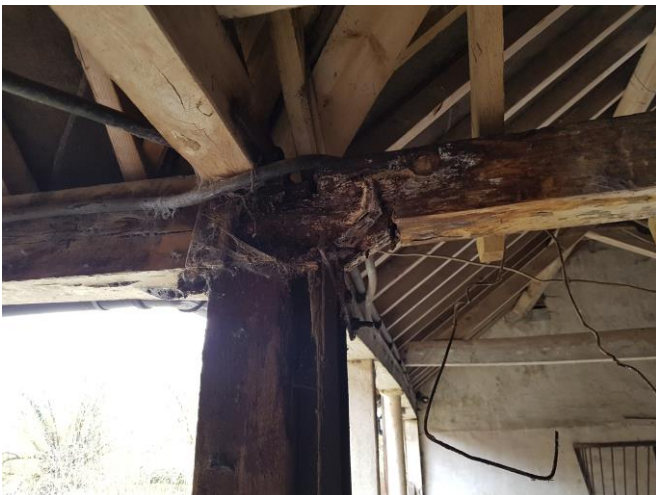
Unit 3 – Decayed Eaves Beam
